GLENWOOD, IOWA

AQUATIC CENTER WATER LOSS INVESTIGATION PRESENTATION

APRIL 29, 2025

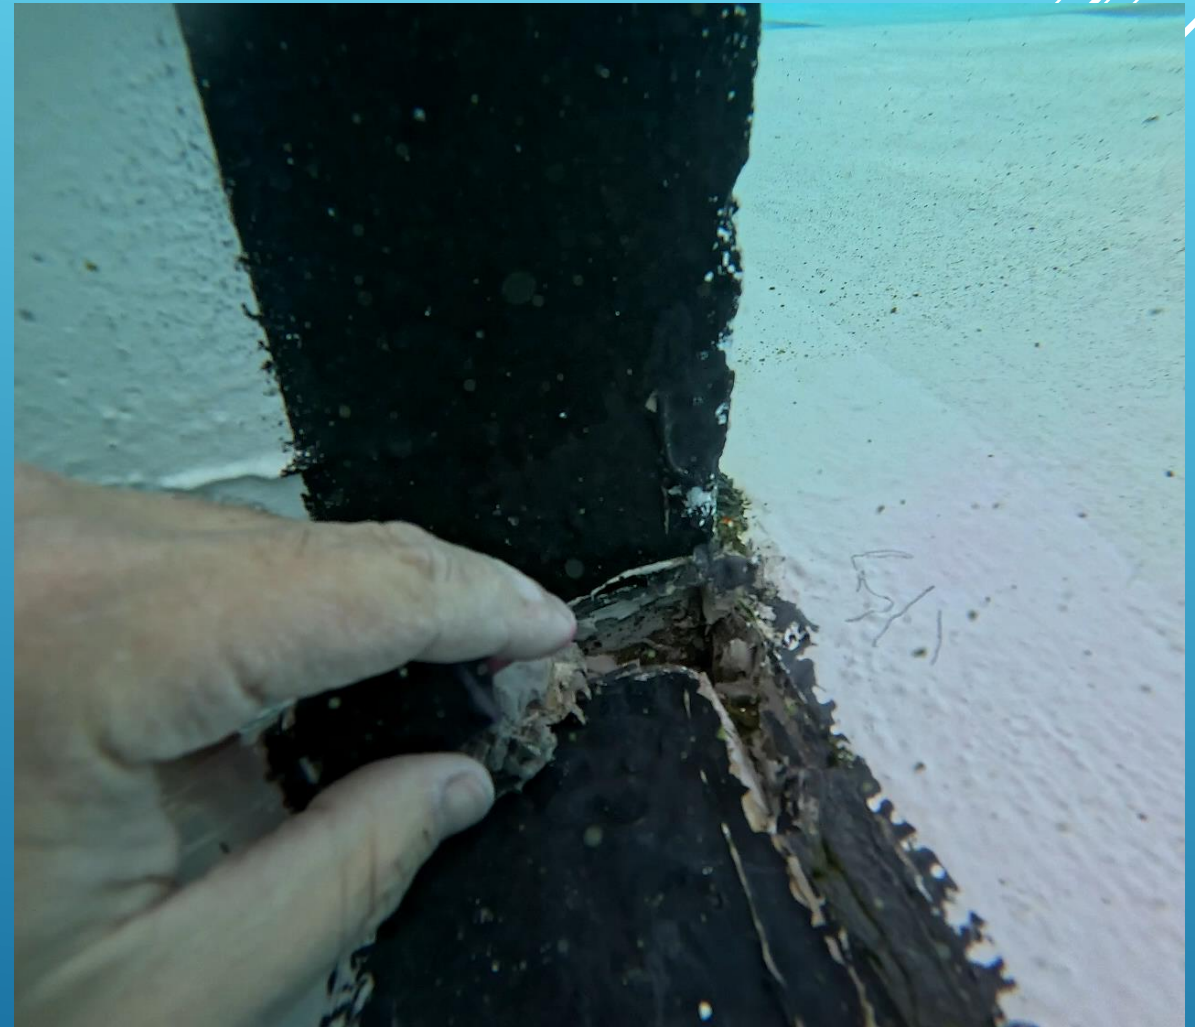
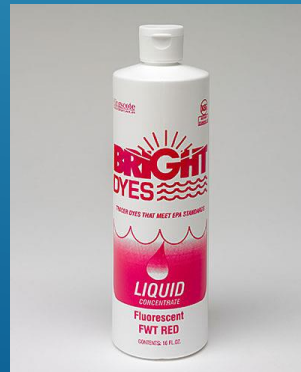
Video: Location 5-1 Showing High Dye/Water Loss

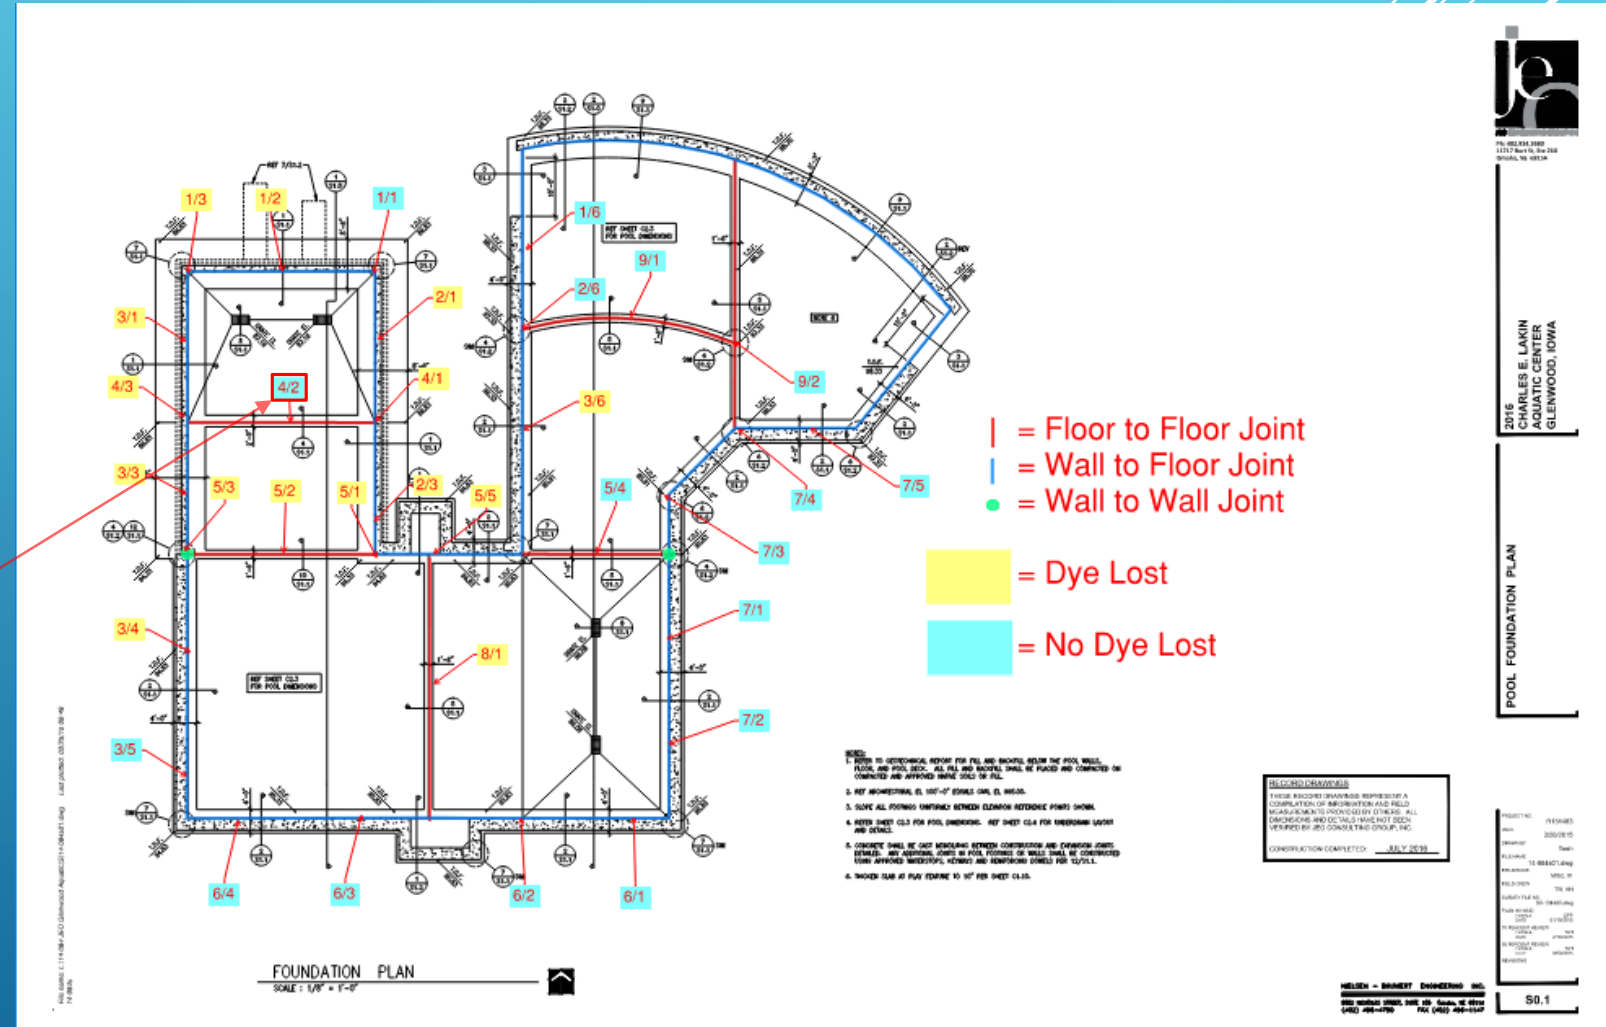
- Dye escaped at most test locations in depths of 5 feet or greater.
- Four additional locations noted in shallow areas

*Note condition

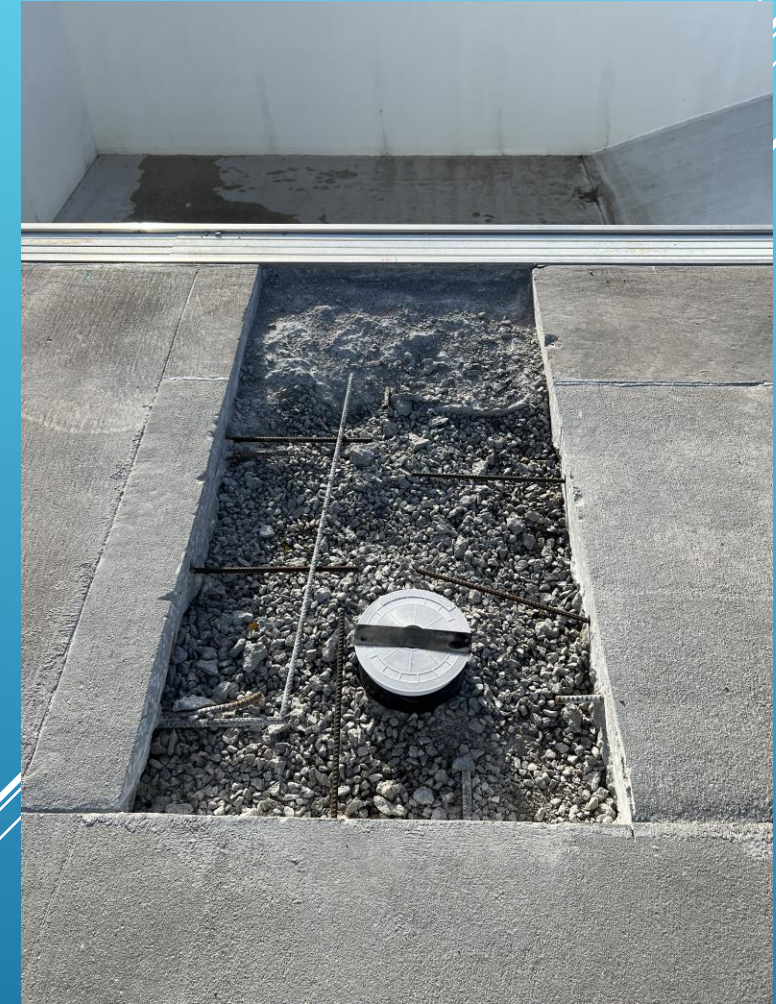
Deck removal and new test port
(1/3)

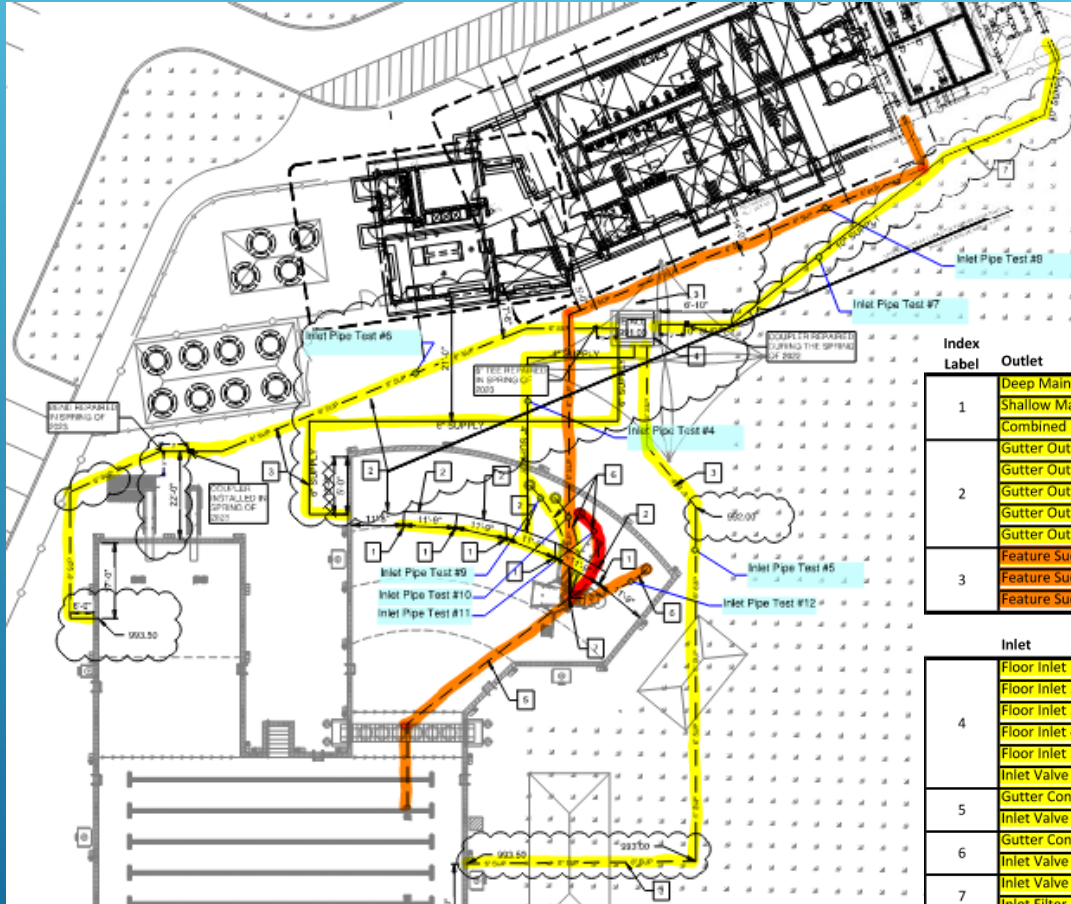
Supply piping

Yellow - Pass
Orange - Leak
Red - No Pressure

- Failed Pipes
 - Heater supply side stream
 - Zero depth bubbler #3
- Leaking Pipes
 - Water feature supply and outlet piping

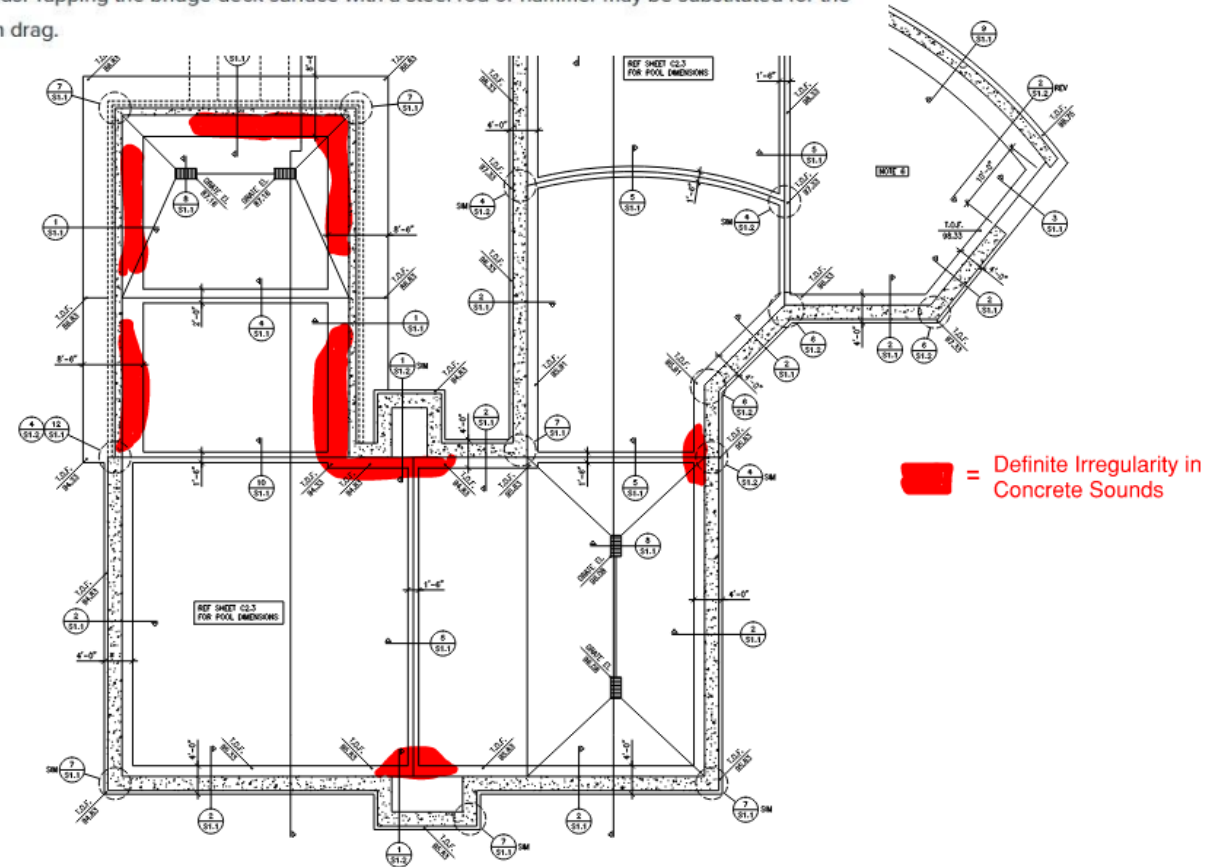
Exhibit Created by BAI

- Definite hollow sounding concrete in areas shown
- Consistent with locations of dye loss

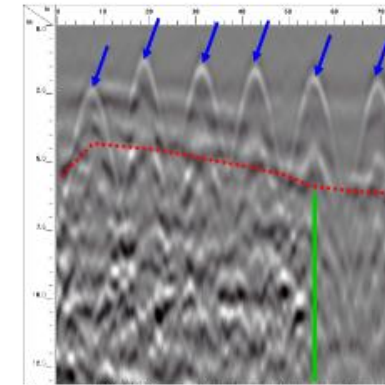
Photograph 10: GPR scan with the approximate slab bottom shown as a dashed red line. The blue arrows denote rebar present in the concrete slab. The green line denotes the apparent boundary between the subgrade and the footing.

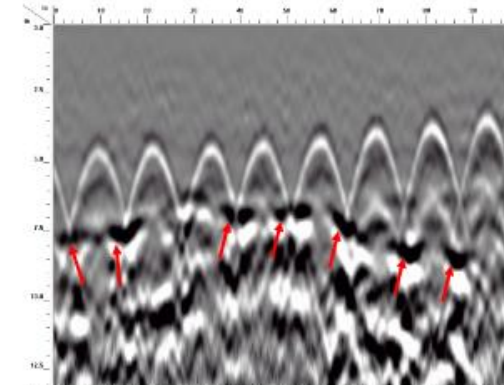
Photograph 11: GPR scan with apparent void areas (red arrows) present below the cast-in-place slab.

- Several multiple apparent void areas
- Apparent void areas consistent with poor sounding concrete and dye loss locations
- Suggests water leaks are eroding the sub grade below the pool floor next to footings
- See Albertson's Report for complete assessment

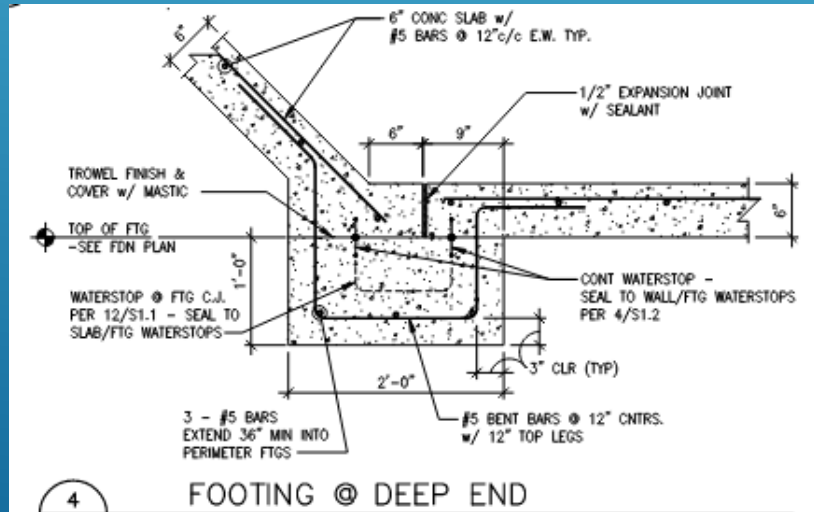
- Light duty 6" floor slab
- Single #5 rebar @ 12" c/c E.W., 1 ¼" at intersection
- Rebar clearance – 1 ½" to surface, 3" to grade
- 4" PVC waterstop
- Floor slab vertical reinforcement only at end of transition slope joint

Only Footing W/ Vertical Reinforcement

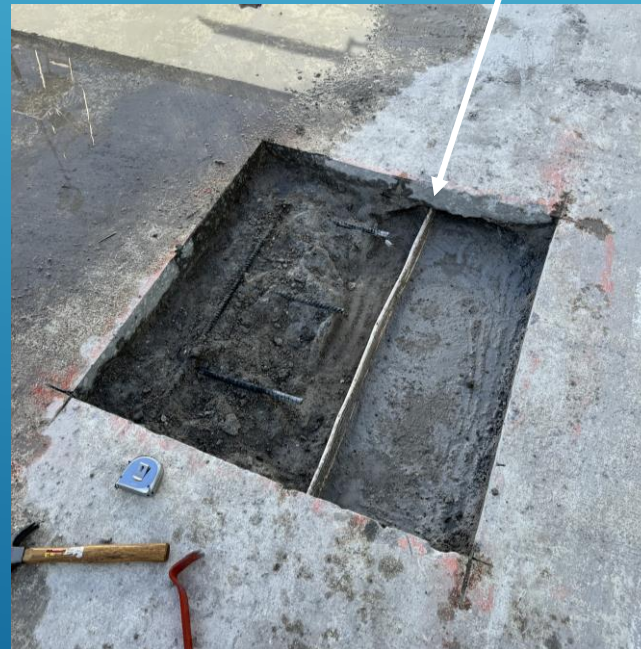
Deep End Opening

- Floor thickness ranges from 4-6 inches (6" design thickness)
- Waterstop is intact but not consolidated
- Confirmed no vertical reinforcement
- Rebar is in contact with waterstop creating poor concrete consolidation at each rebar location
