GLENWOOD, IOWA

AQUATIC CENTER WATER LOSS INVESTIGATION PRESENTATION

APRIL 29, 2025

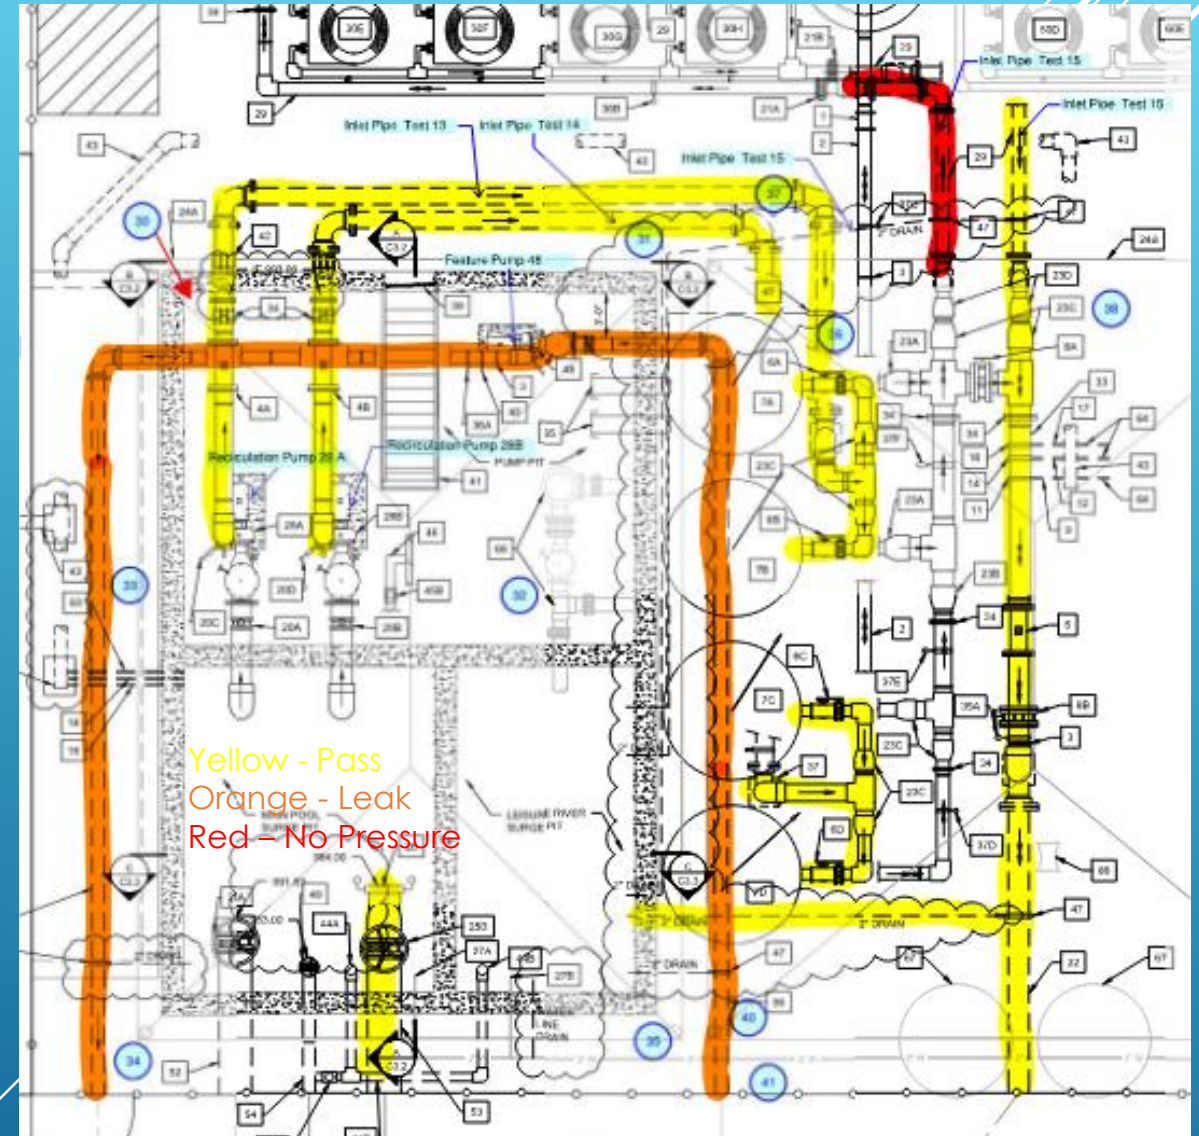
Pool mechanical space piping

- Failed Pipes
 - Heater supply side stream
 - Zero depth bubbler #3
- Leaking Pipes
 - Water feature supply and outlet piping

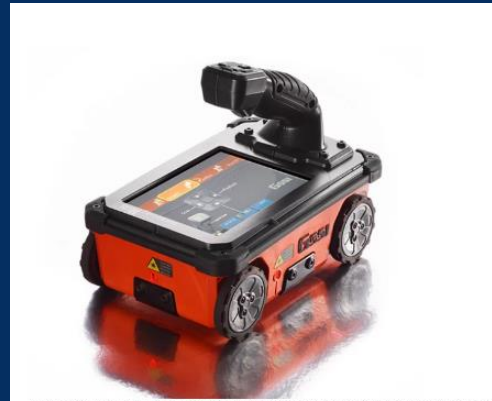
Photograph 8: AEI's in-house GSSI Mini XT scanner used during the field review.

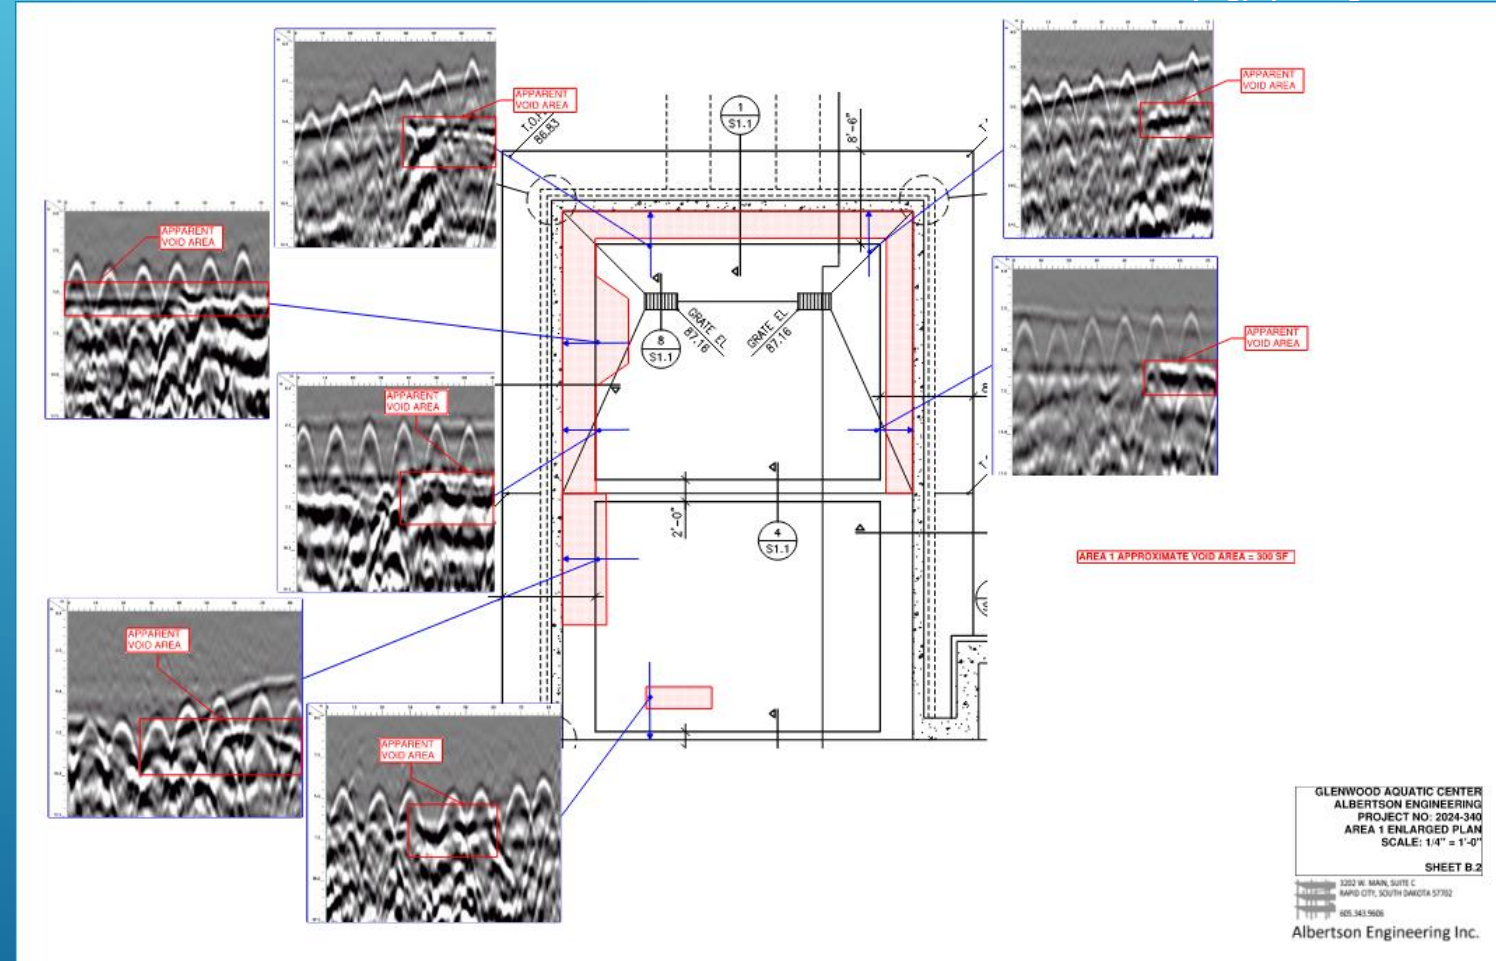
- Several multiple apparent void areas
- Apparent void areas consistent with poor sounding concrete and dye loss locations
- Suggests water leaks are eroding the sub grade below the pool floor next to footings
- See Albertson's Report for complete assessment

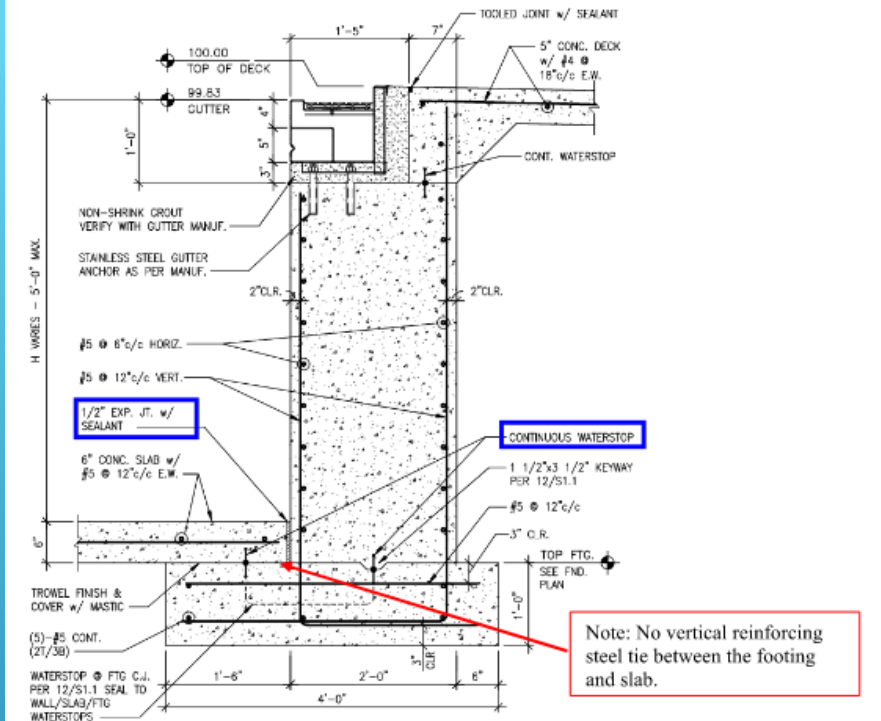
Photograph 3: Detail 2/S1.1 taken from the construction documents. This shows the typical floor slab to perimeter wall detail with the expansion joint sealant and waterstops labeled for clarity.

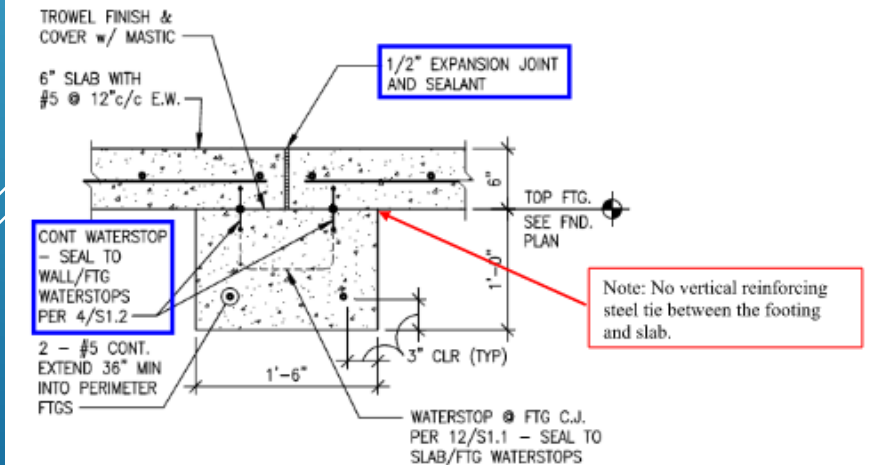
Photograph 2: Detail 5/S1.1 taken from the construction documents. This shows the typical floor slab expansion joint detail with the expansion joint sealant and waterstops labeled for clarity.

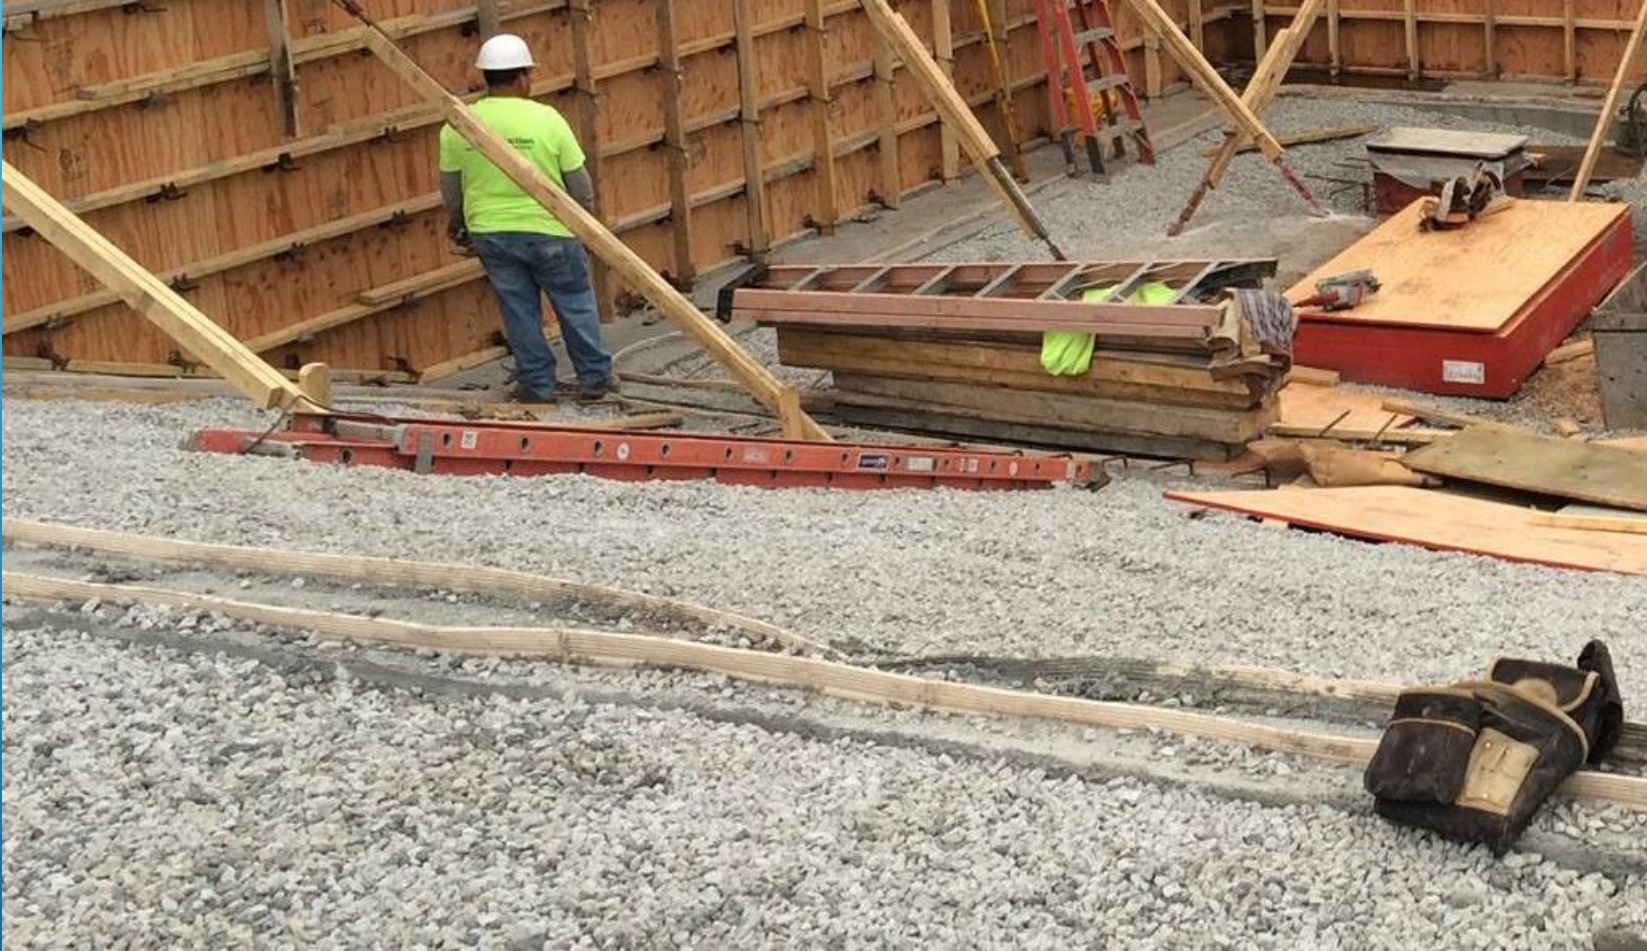
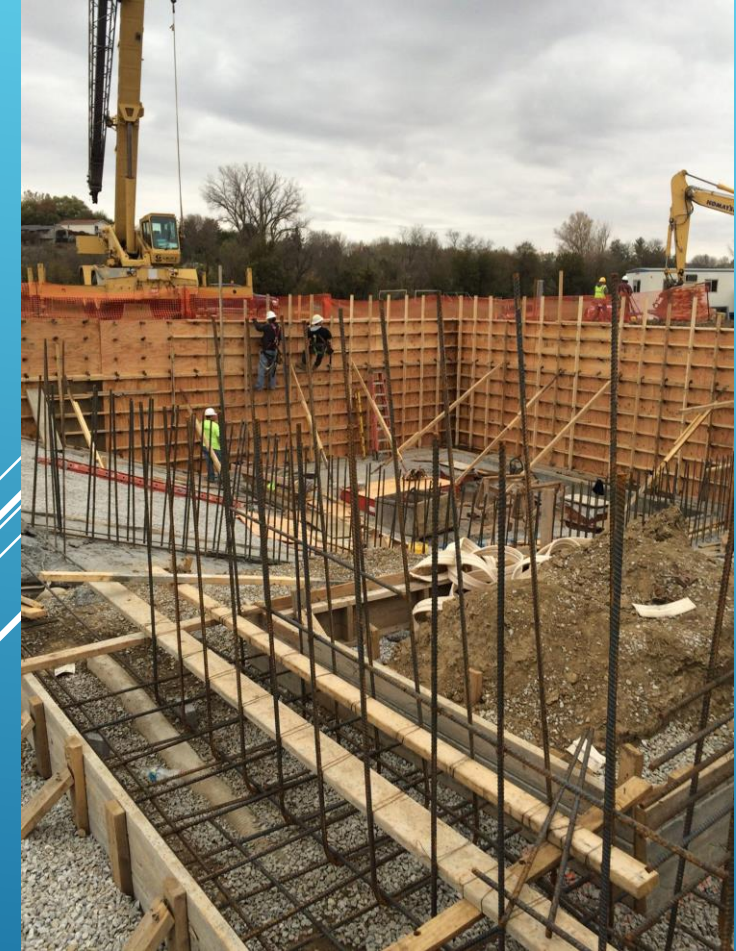
- Light duty 6" floor slab
- Single #5 rebar @ 12" c/c E.W., 1 ¼" at intersection
- Rebar clearance – 1 ½" to surface, 3" to grade
- 4" PVC waterstop
- Floor slab vertical reinforcement only at end of transition slope joint
